Manhole Inspection Summary

Manhole # S43CC_060MH

Insp Date: **6/9/09 1:04 PM**

Location Address: **BOND ST**

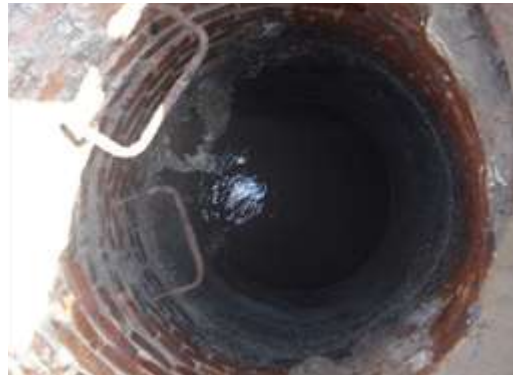
Comments **DOF = 72.0" / SILT = 18.5" / PIPES = 100" / RIM TO CROWN = 8.97' / Pipe Too Big - Top View Cannot Show the Channel**

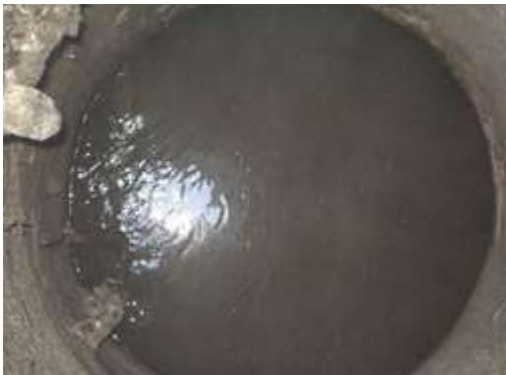
Defect 2

Steps Count: **4** Missing: **4** ☒ **Corroded**

Surcharge ☒ **Evidence Of Surcharge** Depth: **12** (ft.) ☐ Active Surcharge Present

evidence of ASUR and corroded steps

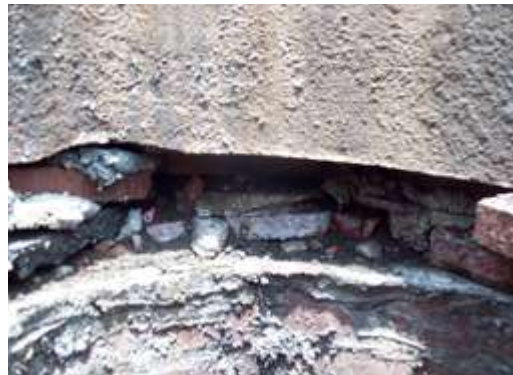
Defect 1

Condition: ☐ Sound ☒ **Cracked** ☐ Root Intrusion ☒ **Loose Brick** ☐ Deteriorated

Chimney
